# Soil Erosion in Rubber Plantations on Kho Hong Hill, Hat Yai District, Songkhla Province, Thailand

**Abstract.** This study aimed to assess soil erosion rate and classification from rubber plantation area and bare soil area as a reference point on Kho Hong Hill in Hat Yai District, Songkla Province, Thailand, where original forest land has been changed to rubber plantation. The study used the USLE method of calculating soil loss using this equation:  $A = RKLSCP$ . The result of soil erosion in rubber plantation on Kho Hong Hill was 100.1 t/ha/year. Such rate is considered very high and can be classified as severe erosion. This research information can help guide the planning decisions for Kho Hong Hill conservation.

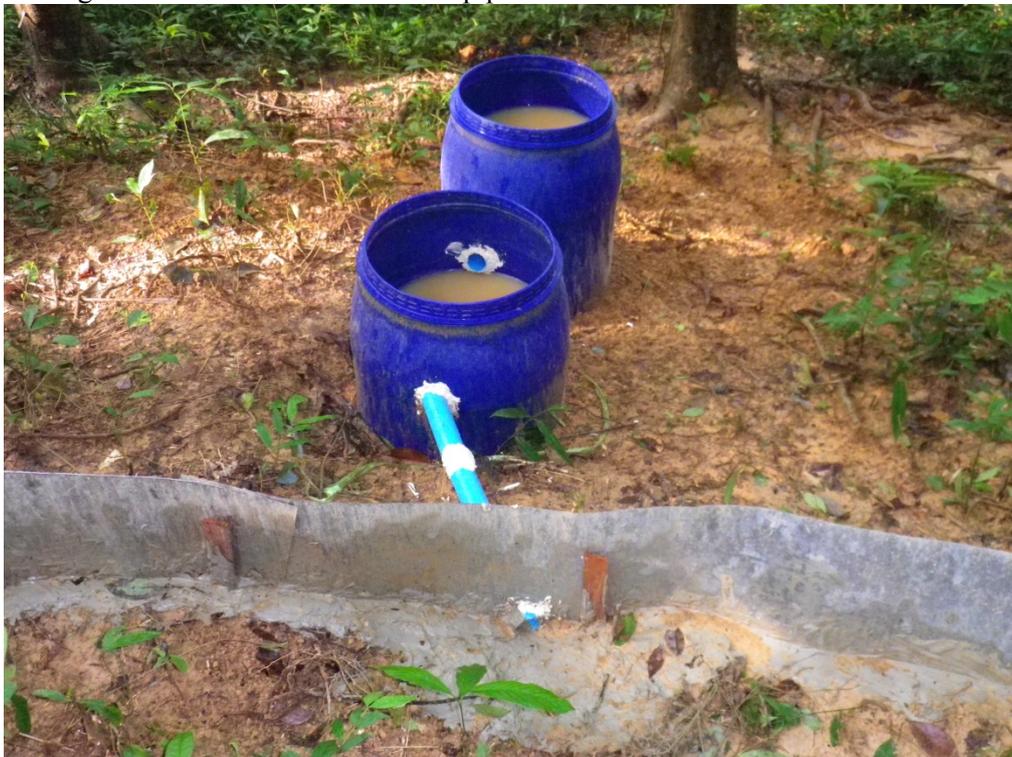
Fig 1: The experimental plot in rubber plantation area.

The size of each experimental plot, both in rubber plantations area and bare soil area, is 4 x 12 meters. The structure of experimental plots is explained as the following:

- Four zinc plates with a height of 30cm were lined on all 4 sides of all the plots by embedding it 10 cm deep into the soil.
- Each experimental plot has 2 plastic tanks to trap sediment. These tanks have a capacity of 100 liters each, with circumference of 168 cm, diameter of 58 cm and surface area of 2,640 sq cm. There was a pipe connecting between these two tanks. The pipe size was 1:10 of the tank size.
